Underworlds and undercrofts

The development of medieval house cellars in urban context

Master Thesis

University of Leiden, Faculty of Archaeology

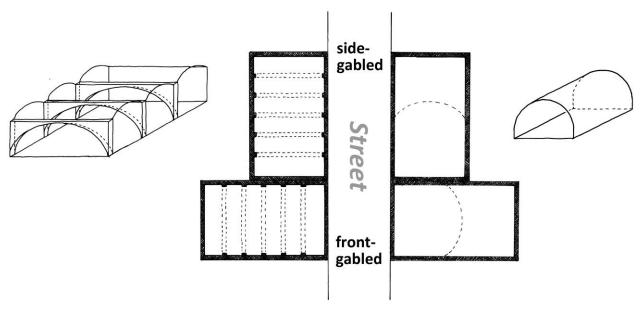
Figure 2.1 Overview of the possible orientations of cellars relative to the street. Cellars with the vaulting types 2a (*right*) and 4a (*left*) are shown, to illustrate in which way the direction of the crown is leading (sources: hand-drawn and edited by author; based on: Haans and Frank 2003, 27 (type 2a) and Koolstra and Willems 2008, 52 (type 4a)).

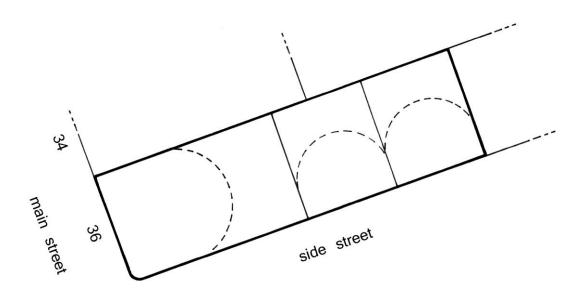
Figure 2.2 Schematic overview of a possible situation in which the orientation of the cellars in the back of a current building may be the indicator to point out that they originally belonged to adjacent buildings that have disappeared over time (source: hand-drawn and edited by author).

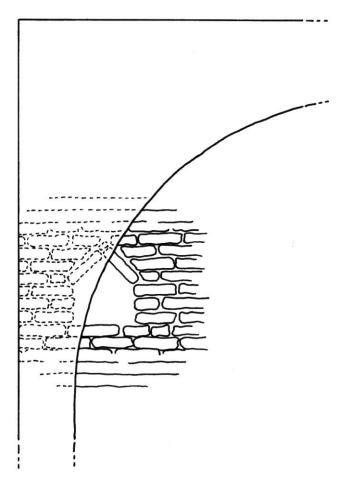
Figure 2.5 Schematic representation of a light niche from an earlier building phase, covered by a younger vaulting (source: hand-drawn by author; partly based on a drawing of Markt 77-79, heritage department of the municipality of 's-Hertogenbosch').

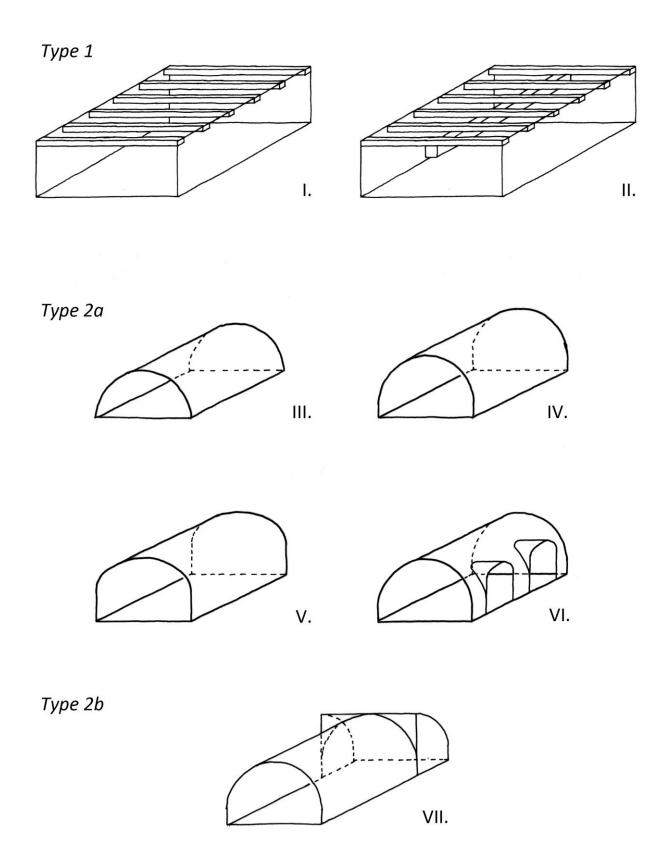
Figure 2.6 Overview of the vaulting types 1 and 2. Type 1: beamed ceiling without supporting beam (I), beamed ceiling with a supporting beam (II); type 2a: barrel vault with a pure round arch and the springer on the ground (III), barrel vault with a pure round arch and the springer above the ground (IV), barrel vault with a pressed vault (or basket-handle arch) and the springer above the ground (V), barrel vault with lunette (*steekkappen*) (VI); type 2b: barrel vault with on the street side a half barrel vault (VII) (sources: hand-drawn and edited by author; based on: Haans and Frank 2003, 27 (IV and VI), Haslinghuis and Janse 2005, 191 (III), Koolstra and Willems 2008, 52 (VII)).

which the planks of the ground floor are located (see Figure 2.6; I). When covering wide spans, these ceilings were provided with an extra supporting beam resting on brick columns Figure 2.6; II). In later times, most beamed ceilings were replaced by stone vaulting.

The second type of vaulting is the oldest and most common type: the barrel vault (type 2), which has a semi-circular cross-section and a rectangular floor plan (see Figure 2.6; III). The barrel Hertogenbosch).

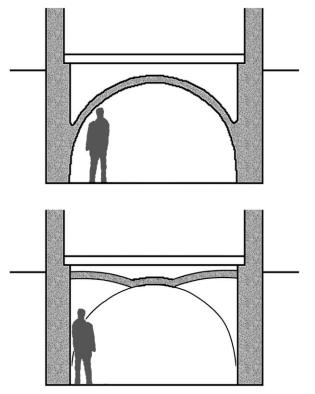
Figure 2.7 Schematic representation of the space in a cellar with a barrel vault (type 2) (*above*) and cross vault (type 3) (*below*) (source: Haans and Frank 2003, 28).

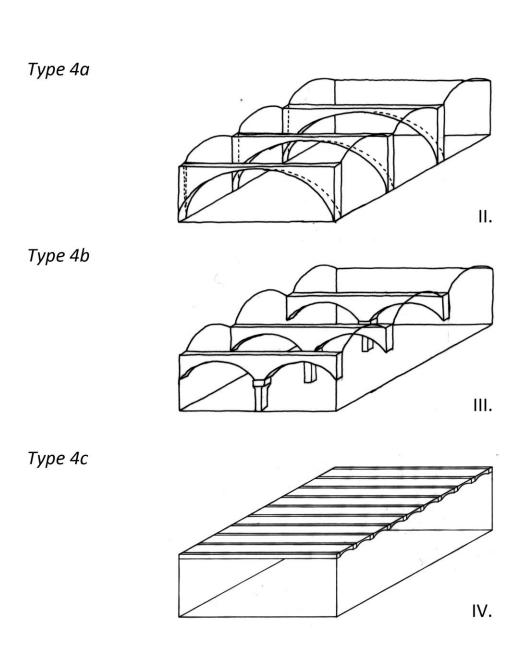
Figure 2.8 Overview of the vaulting types 3 and 4. Type 3: cross vaulting (I); type 4a: trough vault on diaphragm arches (II); type 4b: *Deventer type* (III); type 4c: trough vault with wooden or steel girders (IV) (sources: hand-drawn and edited by author; based on: Haans and Frank 2003, 27 (I), Koolstra and Willems 2008, 52 (II)).

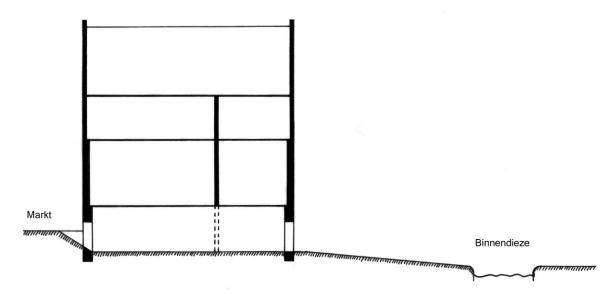
Figure 5.3 Schematic cross-section of a Bosch house located on the Markt (source: hand-drawn and edited by author; based on: Boekwijt 1990, 175).

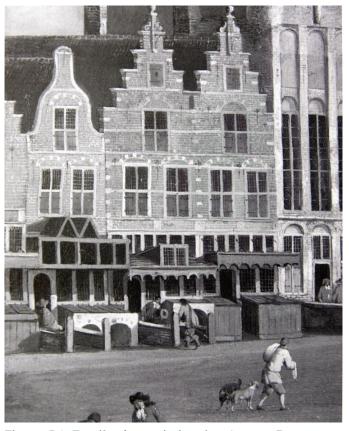
Figure 5.4 Detail of a painting by A. van Beerstraten, showing houses on the Markt around 1664 with canopies, *pothuizen* and cellar entrances (source: van Drunen 2006, 53).

of the main building (see Figure 5.4) (van Drunen 2006, 129). A new type of cellar was introduced during the *versteningsproces* and can be found mostly outside the first city walls. This cellar was located under the rear part of the house and was usually constructed with a barrel vault. As a result of the vault, a difference in level arose on the ground floor between the front and back of the house. The cellar was smaller than the width of the house, making it possible to realize a hallway next to it at the same level as the front house (van Drunen 2006, 89). The cellars were accessible through this corridor and possibly the backyard, which makes them less suitable for renting to third parties (van Drunen 2006, 90).

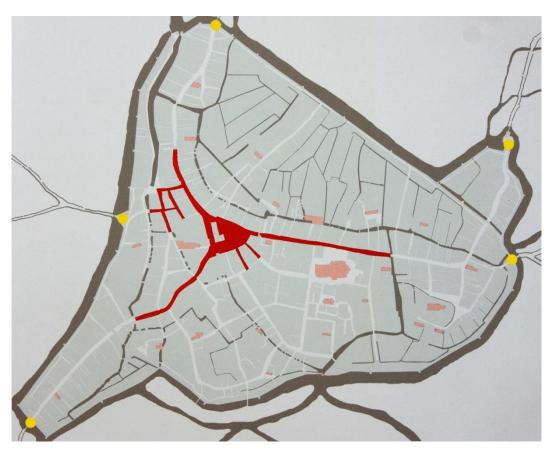
Figure 5.8 Map of 's-Hertogenbosch in the year 1500 AD. In red the streets with houses with a cellar under the front house, the yellow dots represent the most important city gates (source: Enderman 2016, 91).

Houses with a cellar under the front are almost always located on the Markt and at the main streets towards the city gates (Figure 5.8) (Enderman 2016, 91). Only the oldest cellars were located under the entire house (van Drunen 2006, 54). A special phenomenon in this city is the occurrence of street cellars (13%), which are cellars located in front of the house and under the street. They differed in size, but were generally relatively small (approximately 3 x 5m) (van Drunen 2006, 482, note 111). In both other cities, street cellars do not occur on such a large scale as in 's-Hertogenbosch.

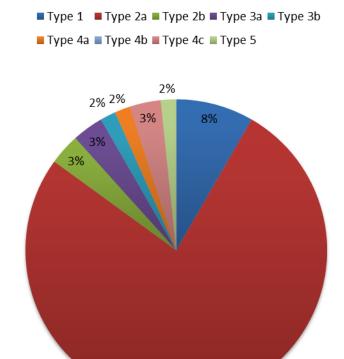
Figure 5.10 Vault types in 's-Hertogenbosch (in %), n=60.

The data from this study (Figure 5.10 and Table 5.5) is in line with the findings from Enderman (2016, 95), who presents that the most common vault type in 's-Hertogenbosch is the barrel vault. He mentions that some barrel vaults are combined with lunette, to create more space along the sidewalls. Unfortunately, barrel vaults with lunette have not been found within the research area of this study. As has already been indicated in section 2.3, there is no further subdivision made than plain barrel vaults with or without half a barrel vault at the street side. Therefore, this variant on the barrel vault is not included separately in the dataset. Furthermore, the presence of cross ribbed and cross groined vaults is exceptional in the city and possibly related in particular to buildings with public functions, such as the cellars under the town hall and the inn in Markt 43 (H21). Even more rarely are cellars with trough vaults on diaphragm arches and beamed ceilings are in general only applied in the oldest cellars of the city (Enderman 2016, 95).

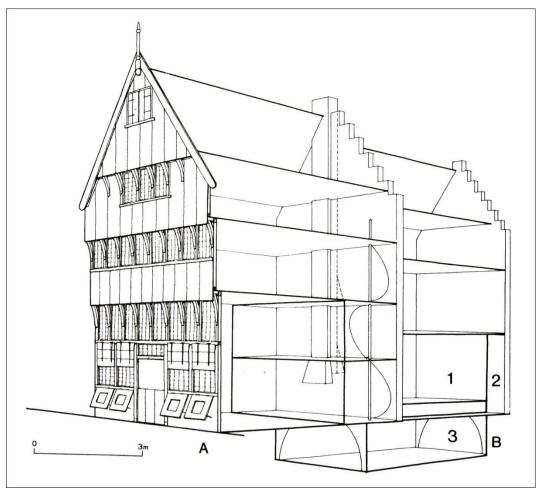
Figure 5.11 The characteristic *Bossche Burgerhuis*, which is divided by a stone fire wall into a front (A) and a back house (B). Next to the *bel étage* (1) of the back house is the hallway at ground level (2) located, through which the cellar (3) was accessed (source: van Drunen 1983, 129; edited by author).

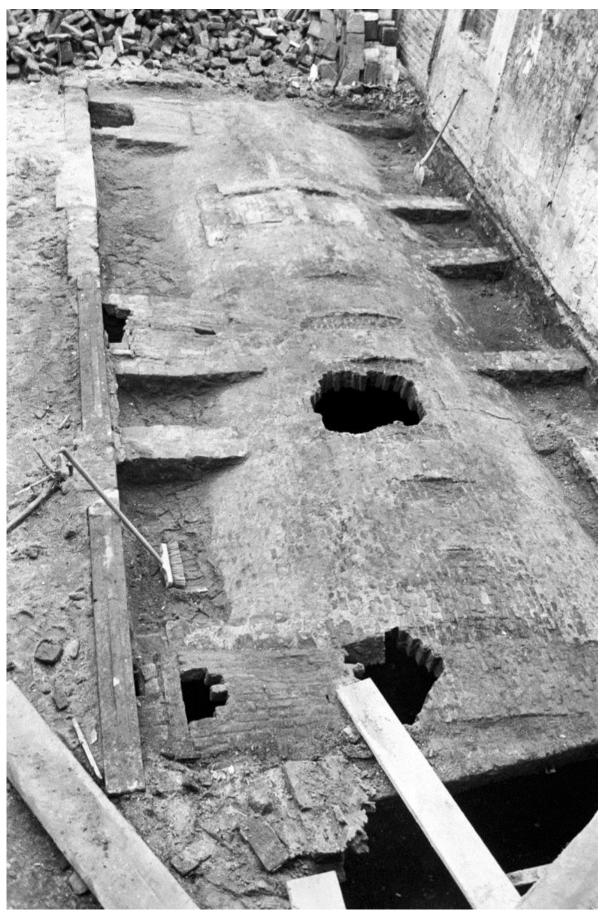
Figure 5.12 A rare top view of a vaulted cellar belonging to Noordenbergstraat 9 (1621) in Deventer. The photo clearly shows how the cellar forms a closed brick space in the ground. The hole in the vault will be of recent date, possibly to realize an internal passage. (source: www.rijksmonumenten.nl; photographed by: Berends, G., April 1971 | License: CC-BY-SA-3.0-NL (wiki)).

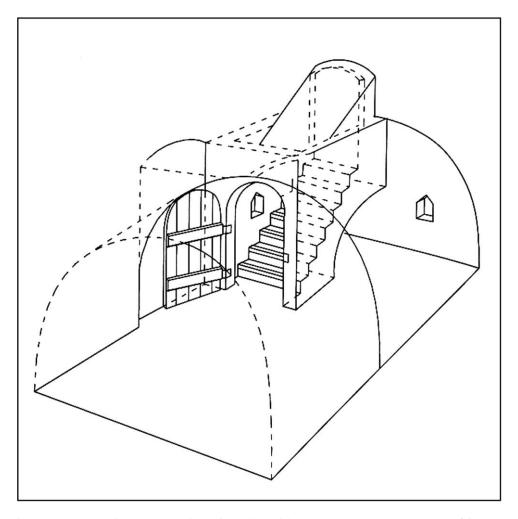
Figure 6.3 Schematic representation of a cellar with a barrel vault and *trapportaal* (source: Haans and Frank 2003, 34).

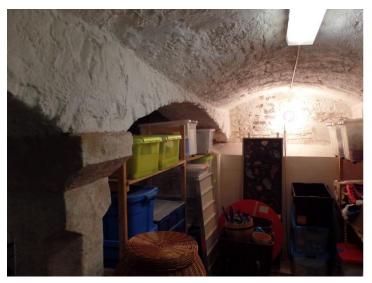
Figure 7.8 Example of a cellar of the *Deventer type* (under Brink 48), including columns of Bentheimer sandstone (source: photographed by author).

As mentioned earlier, the vaulting types that occur in Deventer deviate from the other two cities, therefore it can be stated that there is clearly a city specific cellar type. Typical for Deventer are cellars that usually stretched under the entire house and had an entrance to the street and sometimes the backyard. The vaultings of these cellars mostly consist of trough vaults, placed one after the other, on one transversely placed (parallel to the façade) large diaphragm arch (type 4a) or on double diaphragm arches, which are supported in the middle by sandstone columns (type 4b) (Figure 7.7). This is also recognized by the building historians Bloemink and Hemmes (2003, 5). The latter (type 4b) is so city specific, that cellars with such vaulting are considered as *Deventer type* (see Figure 7.8). These cellars are typical for the late 15th and early 16th century, but they may have occurred much earlier in Deventer (Bloemink 2009, 7). Many of the stone columns are made out of Bentheimer sandstone, a material that was frequently used since 1450 (Vermeulen 2006, 120-121). Similar cellars can also be found in Utrecht and are usually dated in the 15th century, but some even in the 14th century (Bloemink 2009, 7).

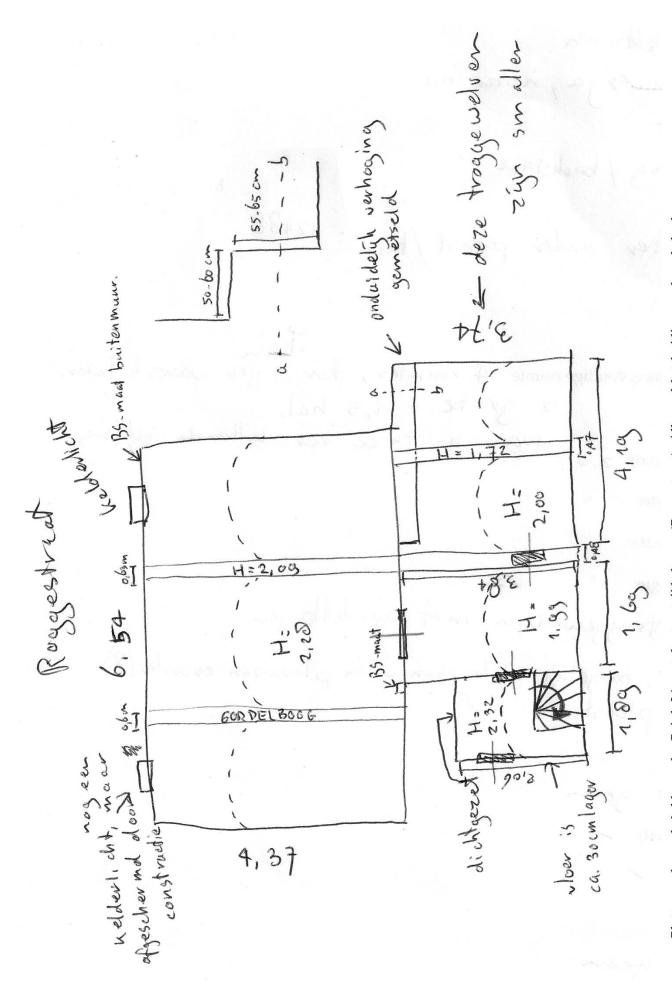
Plattegrond van de kelder onder Brink 21 met de straatzijde boven (Roggestraat). Alhoewel het huidige pand op de hoek Brink-Roggestraat staat, bevindt de (historische) kelder zich uitsluitend onder het deel dat grenst aan de binnenplaats.

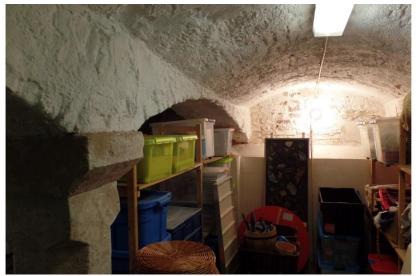
Troggewelven met gordelbogen steunend op zuilen van Bentheimer zandsteen

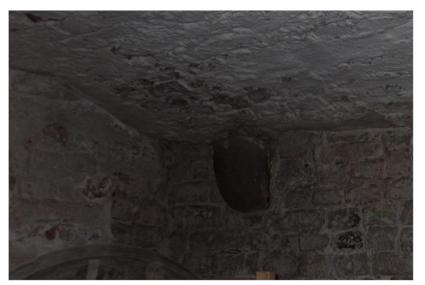
Deze draagsteen is een mogelijke aanwijzing dat de gewelfconstructie pas later is aangebracht

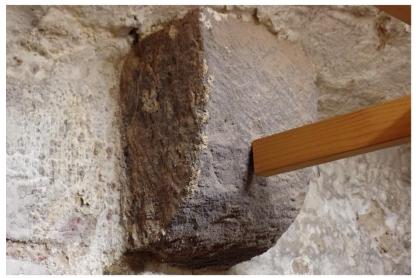
Detail draagsteen

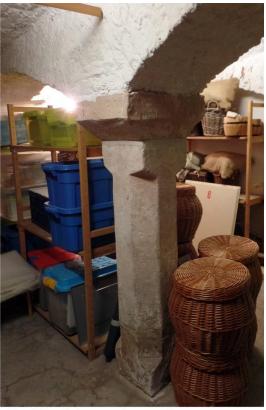
Detail Bentheimer zandsteen zuil

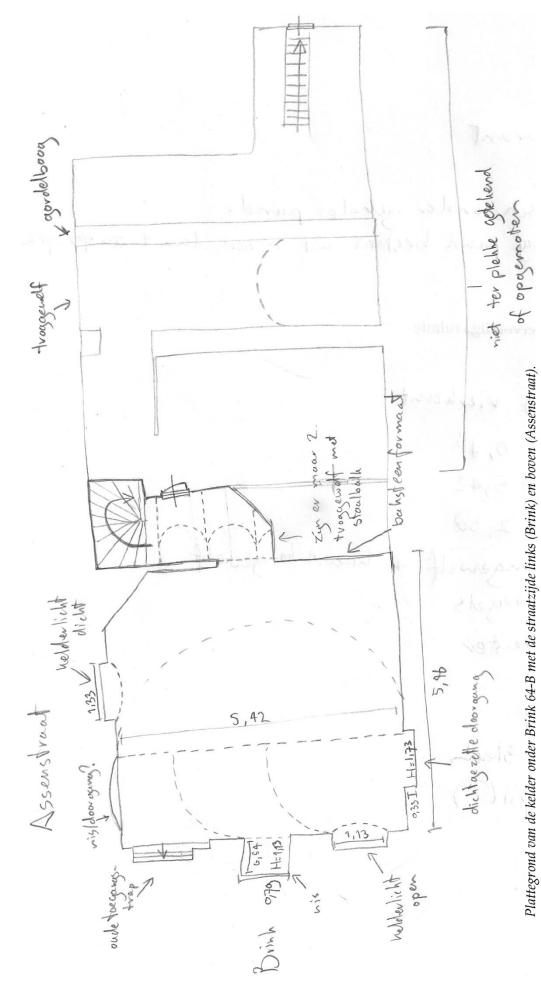
Plattegrond van de kelder onder Brink 64-B met de straatzijde links (Brink) en boven (Assenstraat). Het gedelte rechts van de trap is wel bezichtigd, maar niet ter plaatse opgemeten, dus het betreft hier een globale schets.

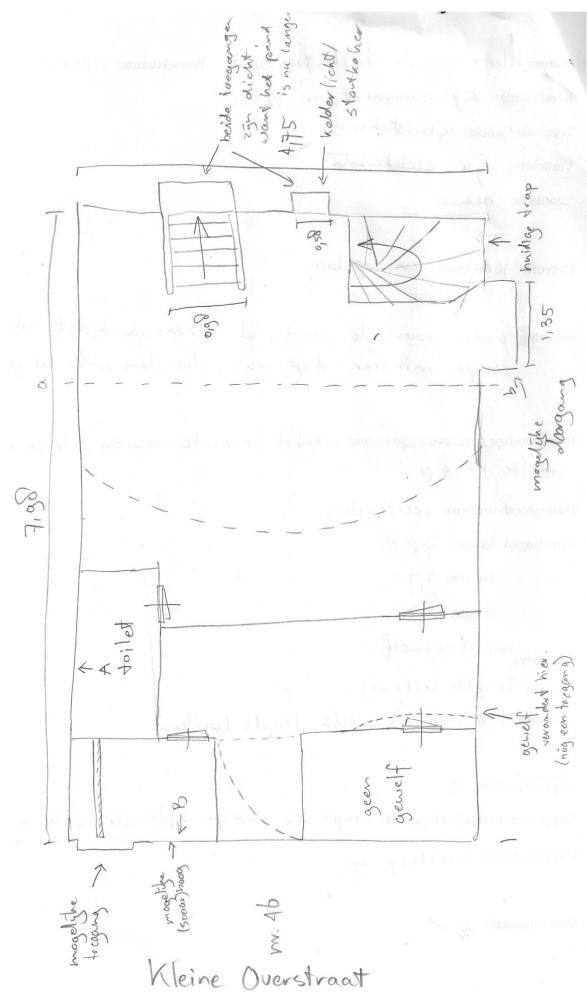
Plattegrond van de kelder onder Kleine Overstraat 46 met de straatzijde links.

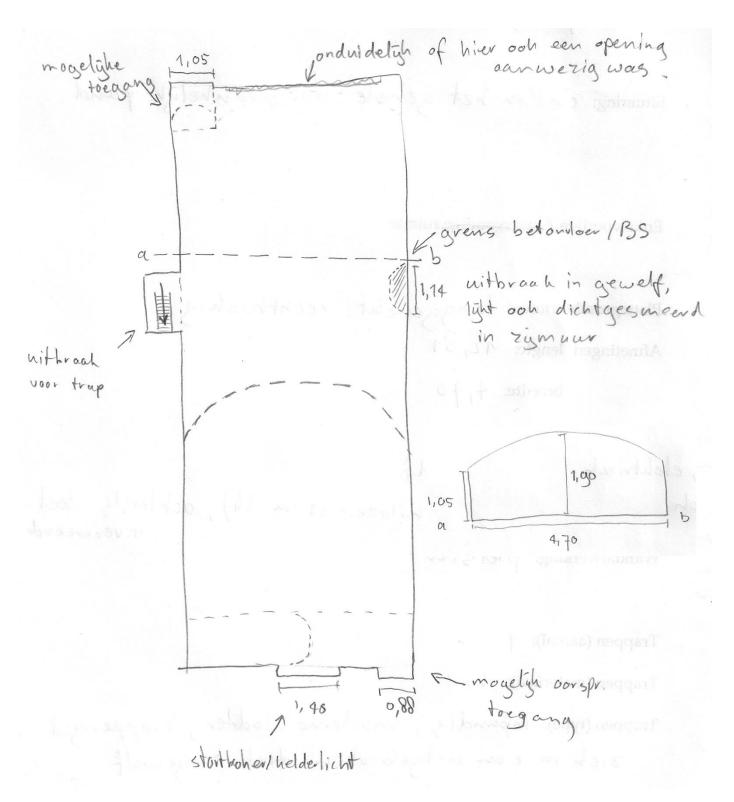
Plattegrond van de kelder onder Korte Bisschopstraat 33 met de straatzijde onder.

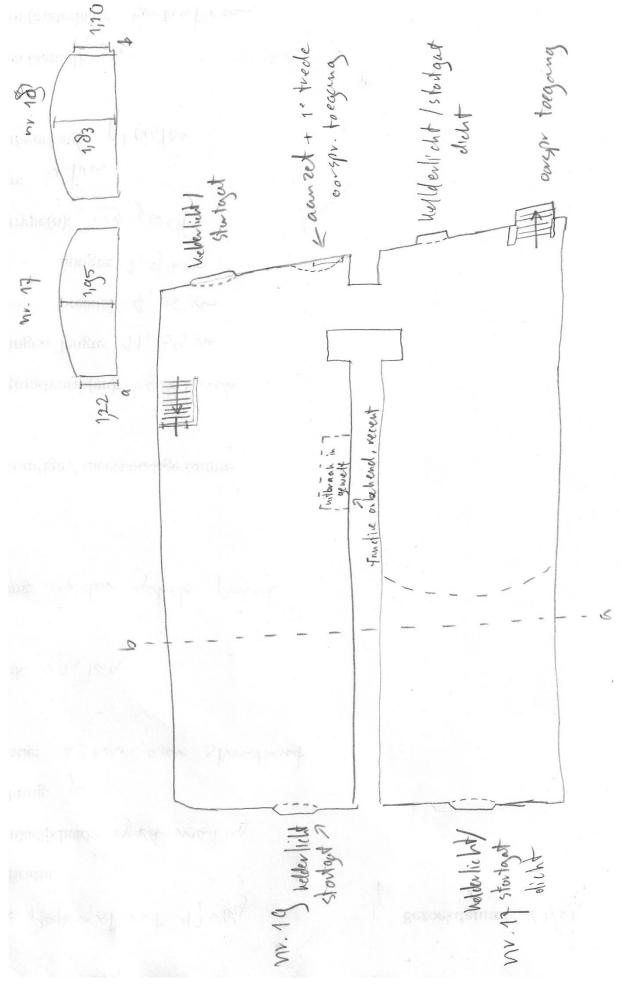
Plattegrond van de kelders onder Papenstraat 17 en 19 met de straatzijde rechts. De afmetingen van de bovenste kelder (nr. 19) zijn 10,94 x 3,96 x 1,82 m, van de onderste (nr. 17) 11,33 x 4,05 x 1,94 m.

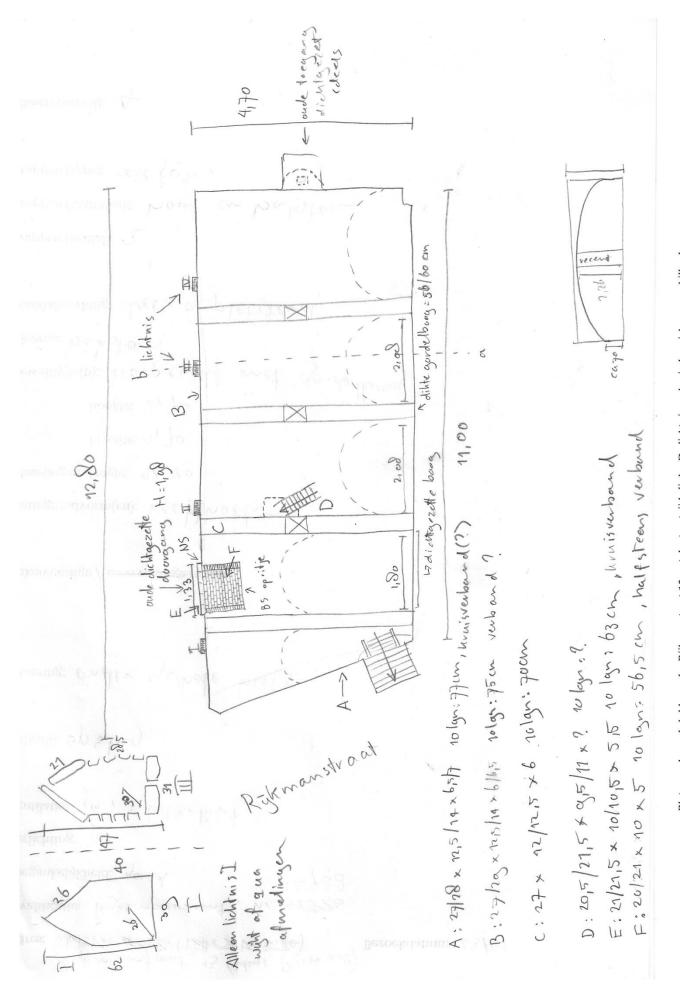
Plategrond van de kelder onder Rijkmanstraat 13 met de straatzijde links. De lichtnissen bevinden zich op verschillende afstanden ten opzichte van de gordelbogen, dit kan erop wijzen dat de gordelbogen later pas zijn aangebracht.

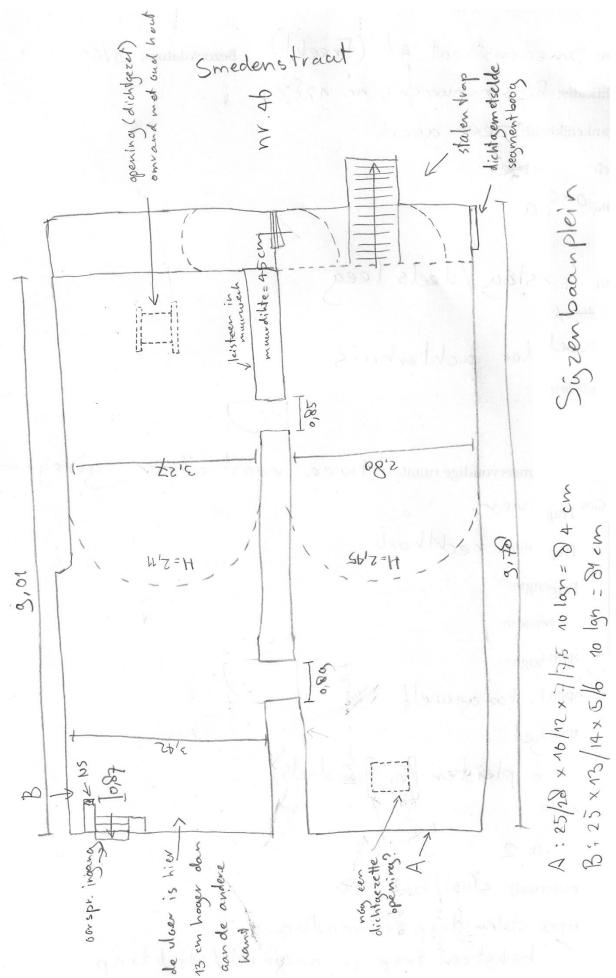
Plattegrond van de kelders onder Smedenstraat 46 met de straatzijde rechts (Smedenstraat) en onder (Sijzenbaanplein).

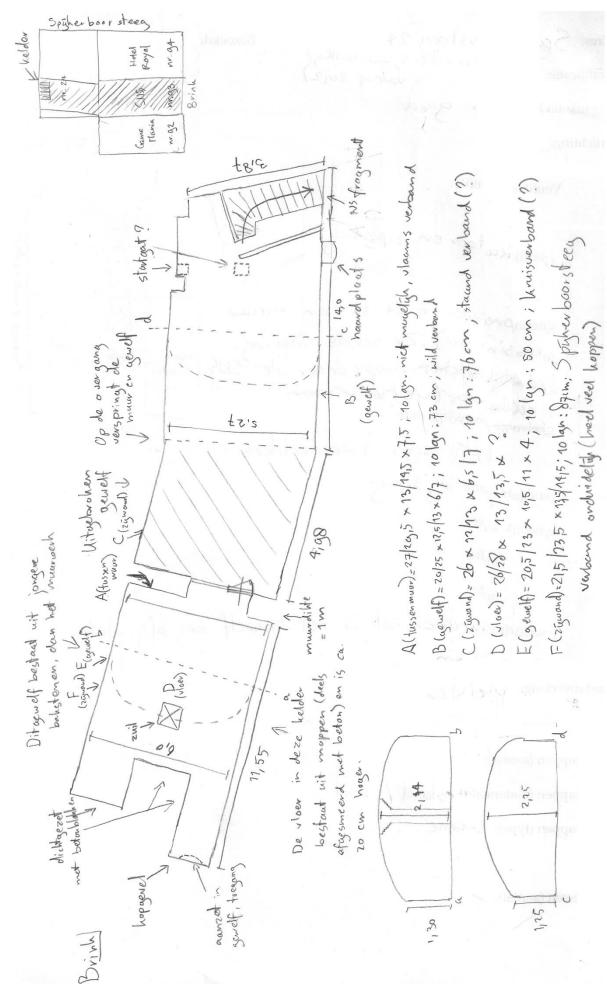
Plattegrond van de kelder behorende tot Spijkerboorsteeg 24, maar liggende onder Brink 39, met de straatzijde links (Brink) en onder (Spijkerboorsteeg). Rechtsboven een bovenaanzicht van de situering van de kelder.

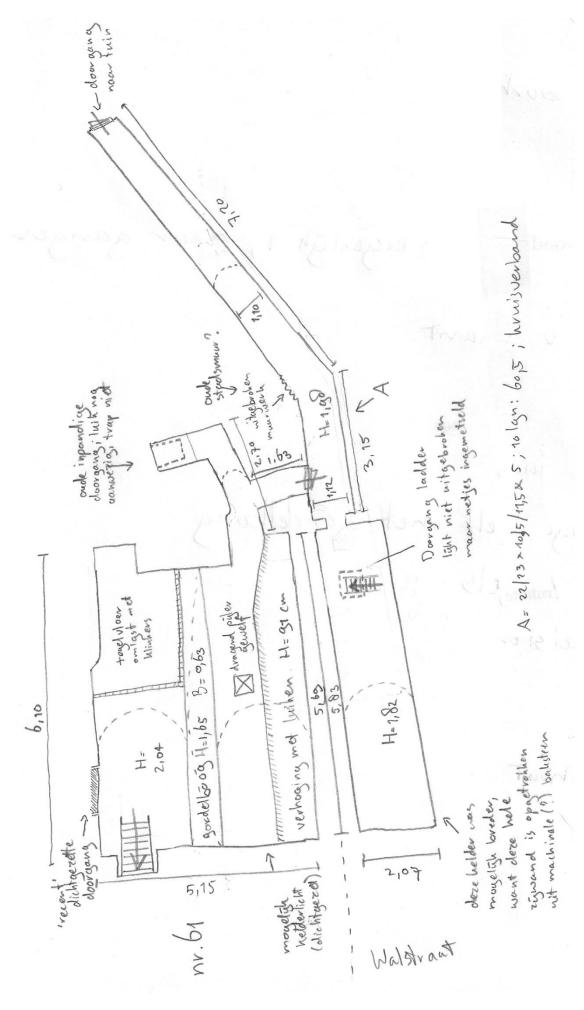
Plattegrond van de kelder onder Walstraat 61 met de straatzijde links. De lange gang eindigd op maaiveldhoogte in de achtertuin. In de knik in de gang bevinden zich restanten van de stadsmuur.
