VISUALISING CASTLES

Representations in 3D of castles in the Duchy of
Holland during the period of 1300-1700

How 3D modelling can contribute to understanding Dutch castles in the regions of Delft,
Haarlem and Zoetermeer.

Course: MA thesis Archaeology

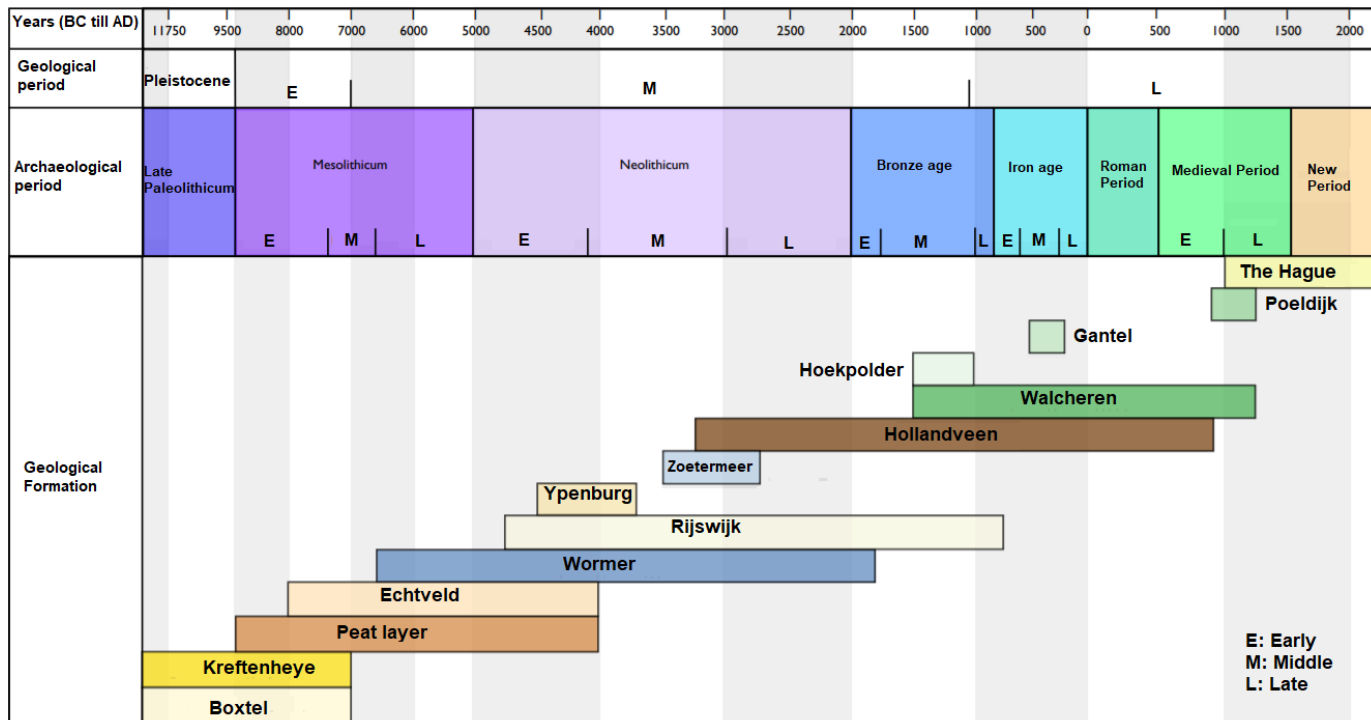
Figure 3: A schematic overview of the geological layers within Holland (After Kerkhof 2012, 11).

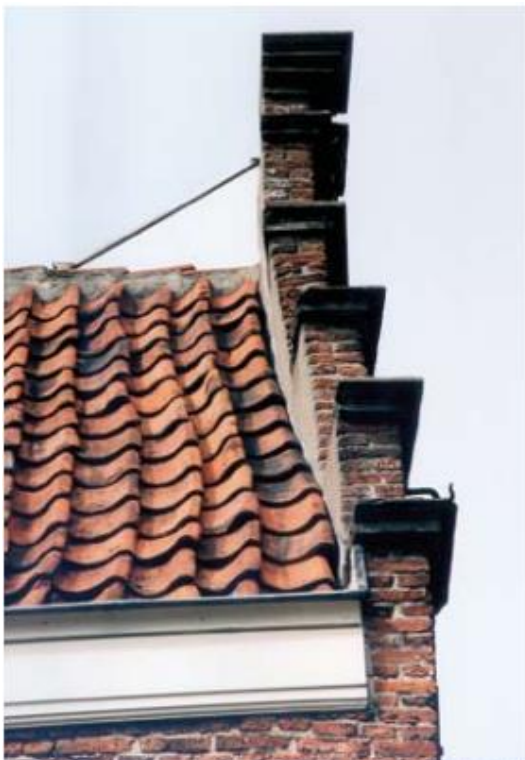
Figure 7: In 1466 a new type of tiles came into use in Holland, the “Zwolse Quakpan”, whose design quickly became known in Dutch as the “*gegolfde holle pan*” which is depicted on the image (Polman and van Rooden 2008, 2).

On figure 7, the roof appears to be a crow stepped gable design (www.Kwaard.net 2004). This design begins to appear in Holland around 1600 (www.Kwaard.net 2004). The steps of this type of roof have a perpendicular triangular shape pointing inwards, towards the roofing (Agnete Olsen 1981, 161). The function of this triangular shape appears to collect rainwater.

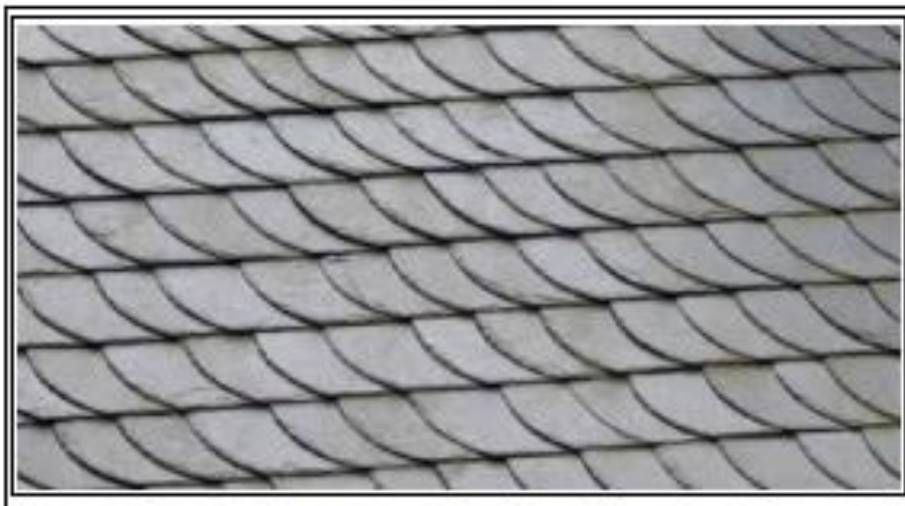
Figure 8: These slate tiles, which are formed into a scale like style (Boeder and Tolboom 2010a, 1).

When the shape of the tiles has a scale like appearance, such as on figure 8, the Dutch term “*Rijndekking*” is used as a description (Boeder and Tolboom 2010a, 1). Slate tiles are expensive and display a high social economic status (Boeder and Tolboom 2010a, 2). The roof of towers and halls of the main castle can be assumed to have been covered with late tiles. The “*Rijndekking*” tiles appear in the southern- and western parts of the Netherlands (Boeder and Tolboom 2010a, 2).

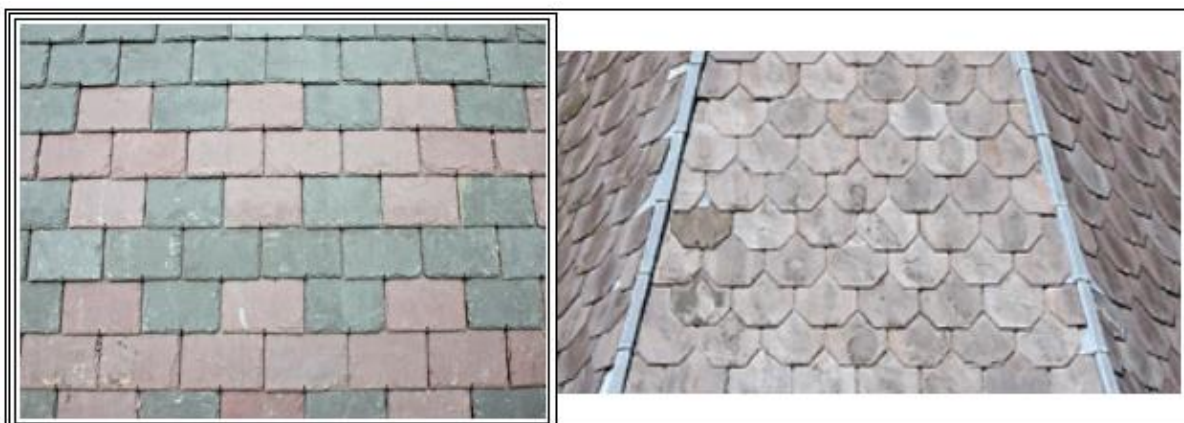
Figure 9: Two different forms of square slate tiles (After Boeder and Tolboom 2010b, 1-3).

The square slate tiles at display here are described in Dutch as “*Maasdekking*” (After Boeder and Tolboom 2010b, 1-3). This design is common in the northern- and eastern parts of the Netherlands (Boeder and Tolboom 2010b, 2). At the right side of figure 9 is a version with chamfered corners of this type of tiles, which is described under the term “*lamme koppe*” (Boeder and Tolboom 2010b, 3).

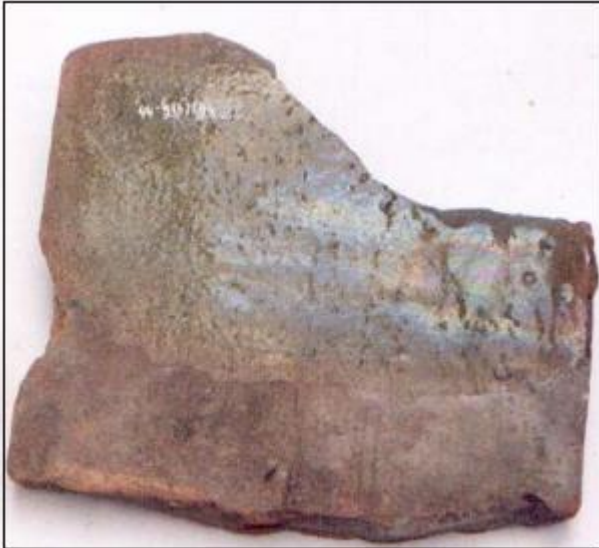
Figure 10: An example of a flat roof tile (Hupperetz, 2004, 86).

A type of roof tiles, of which figure 10 is an example (Hupperetz, 2004, 86; Polman and van Rooden 2008, 2). The design of square ceramic flat roof tiles follow the pattern of slate tiles (Polman and van Rooden 2008, 2).

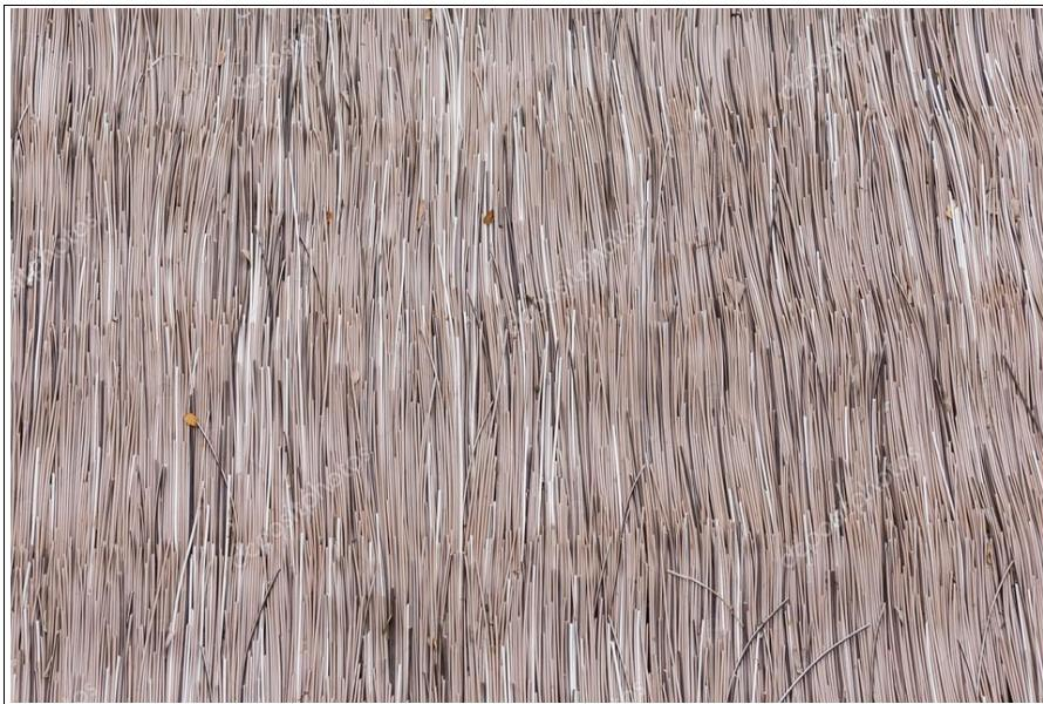
Figure 11: Hay texture for roofs of organic material (mx.depositphotos.com, 2015).

One final type of roofing is organic roofing, in which organic material, such as hay (Polman and van Rooden 2008, 2). This type of roofing was in use until the 14th century, as it was cheap (Polman and van Rooden 2008, 2). When fires in cities arose in the middle of the 14th century, this type of roofing was forbidden (Polman and van Rooden 2008, 2). On figure 11, the implemented texture for organic roofs is displayed.

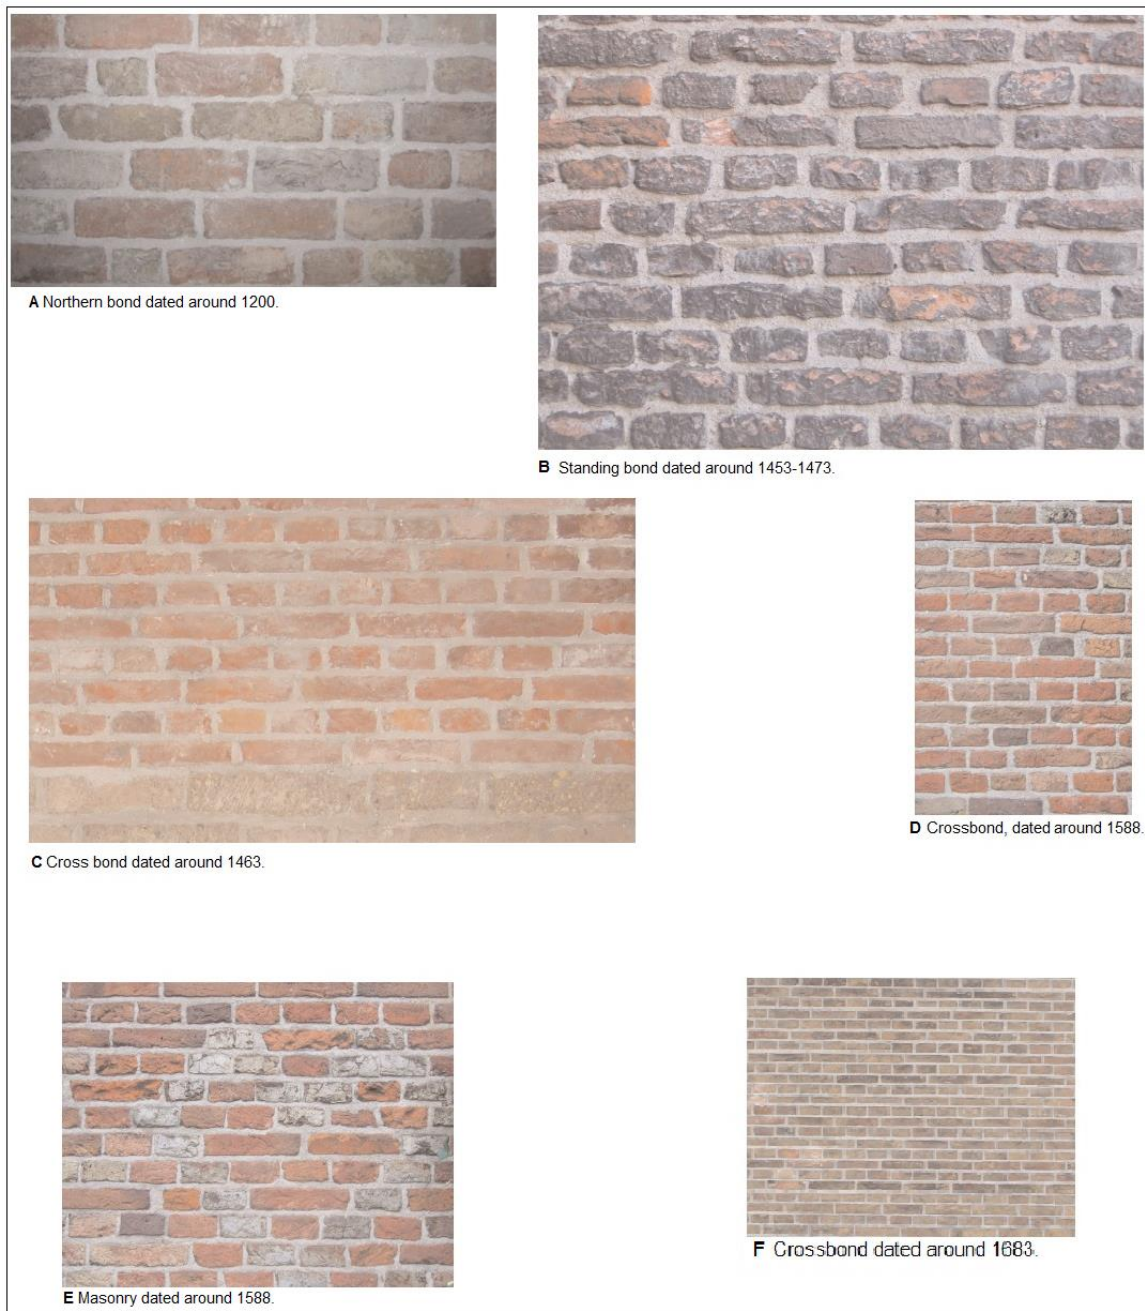
Figure 18: The textures of the brickwork (Orsel 2007, 6-19).

In the work of Orsel, an overview of bonds in brick is presented, which originate from buildings in Leiden, which is in part depicted on figure 18 (Orsel 2007, 6-19). Image A depicts a brick wall with northern bond, dated around 1200 (Orsel 2007, 6). Image B depicts a standing bond from the period 1453-1473 (Orsel 2007, 16). Image C depicts cross bond masonry, dated around 1463 (Orsel 2007, 16). Image D depicts cross bond of around 1588 (Orsel 2007, 18). Image E depicts a sign of the mason, and appears to be cross bond, dated around 1588 (Orsel 2007, 5). Image F depicts cross bond dated around 1683 (Orsel 2007, 19). The images A, B and C depict masonry before the research period of 1300-1700. This is purposely done, as in all the castles, elements predate 1300, which still need the proper texture.

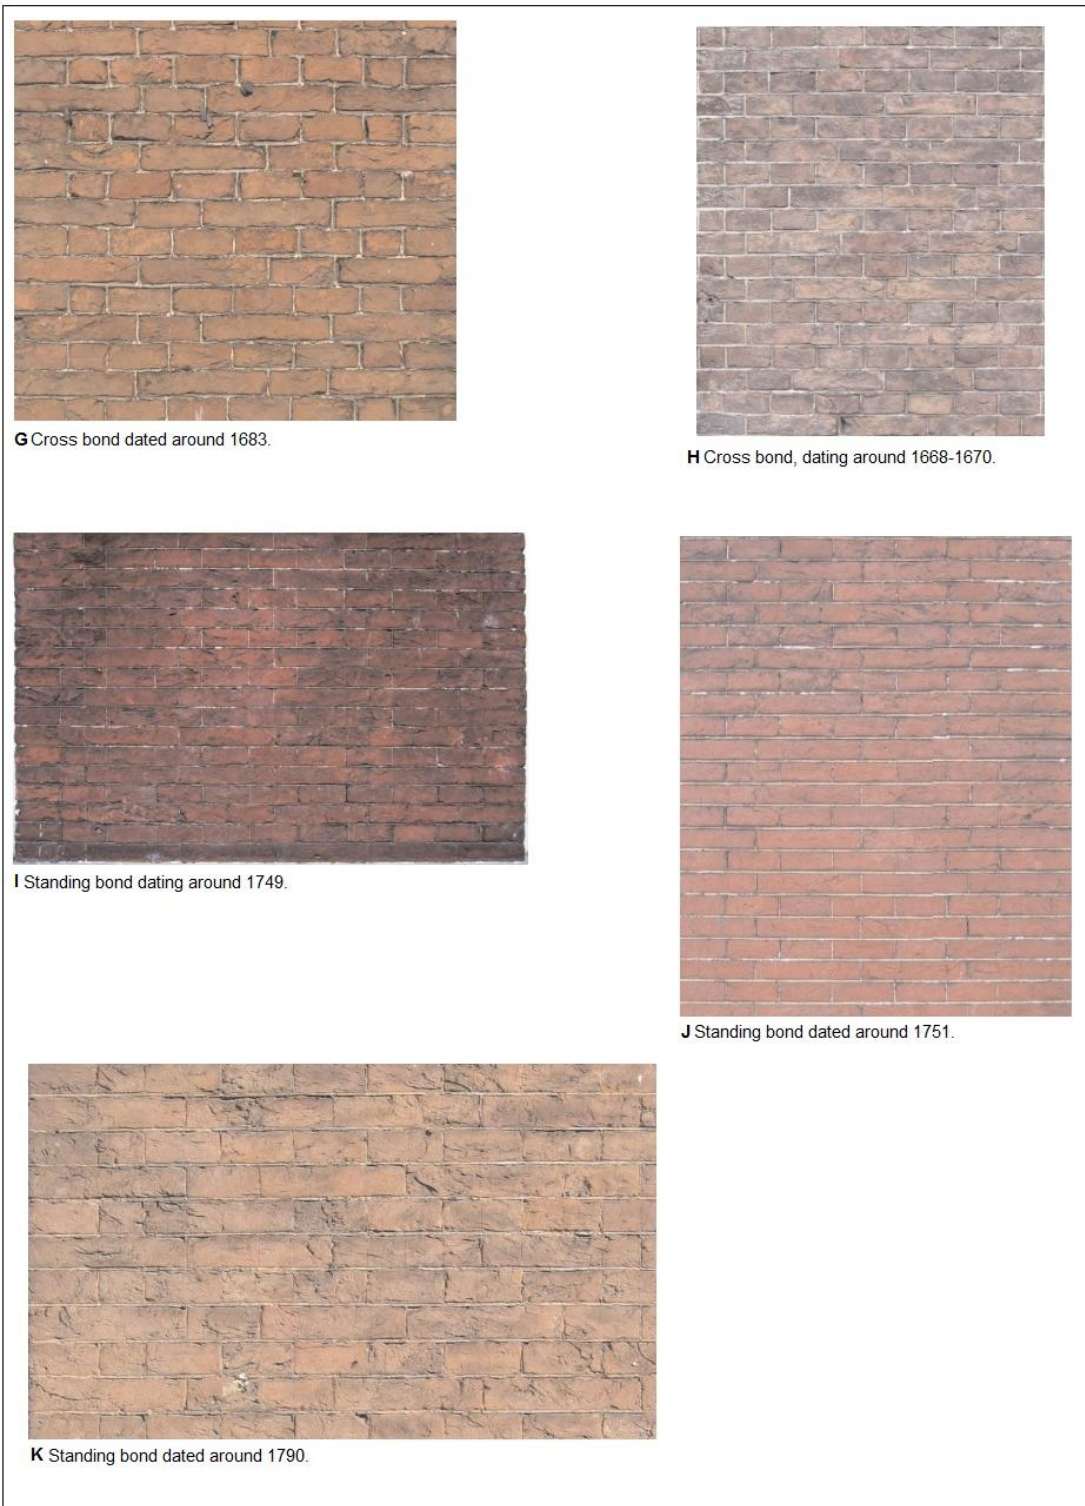
Figure 19: The textures of the brickwork (Orsel 2007).

In the work of Orsel, several other images of brickwork, of buildings in Leiden, are depicted, which is in part depicted on figure 19 (Orsel 2007). Image G depicts cross bond dated around 1683 (Orsel 2007, 18). Image H displays cross bond dating roughly from 1668 until 1670 (Orsel 2007, 20). Image I depicts standing bond, and dates around 1749 (Orsel 2007, 20). The standing bond on image J depict high quality and slightly older brick wall, dating roughly from 1751 (Orsel 2007, 17). Lastly, image K displays standing bond around 1790 (Orsel 2007, 17). There are

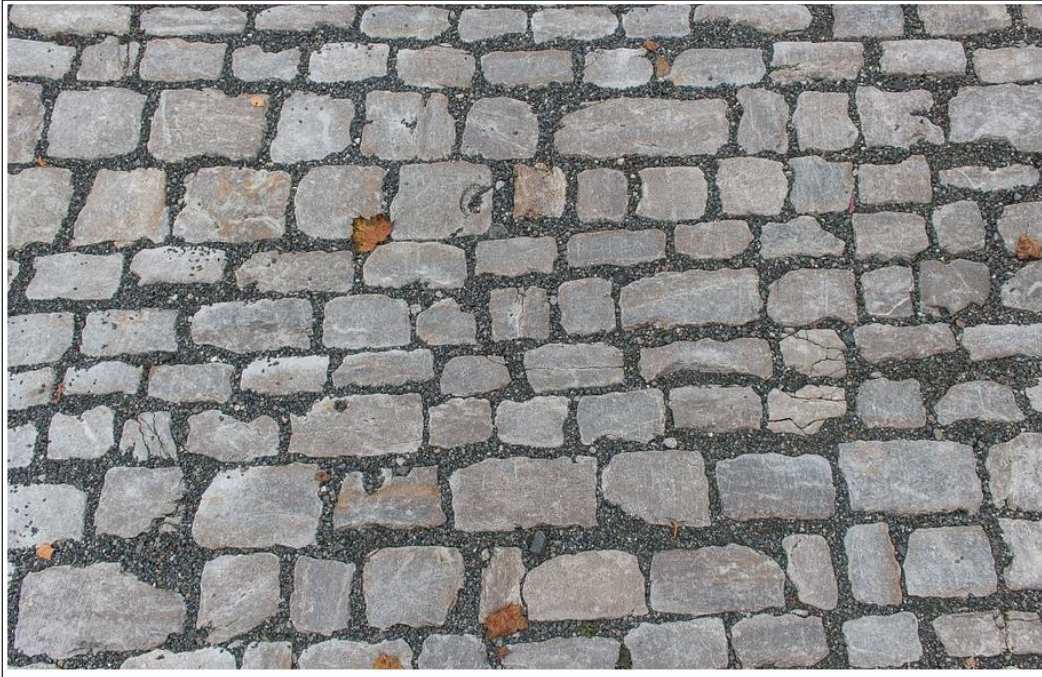
Figure 23: The texture of a medieval road (Pixabay 2019).

The location of at least one castle is directly facing a street. In order to display a reliable image, a texture of a medieval road, as seen on figure 23 is implemented in the models.

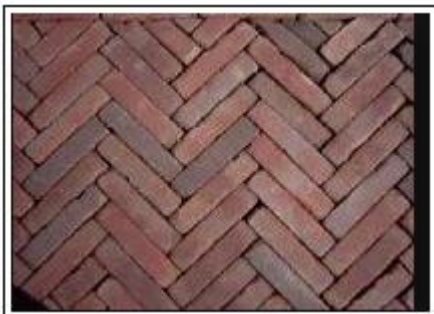
Figure 24: Keperbond, present as a floor in the castle of Huis ter Kleef (After Werkspot 2009).

In figure 24, the bond type of Keper is displayed. In a discussion Numan mentioned that this type of bond is used for floors, and is present on the inner court of Huis Ter Kleef.

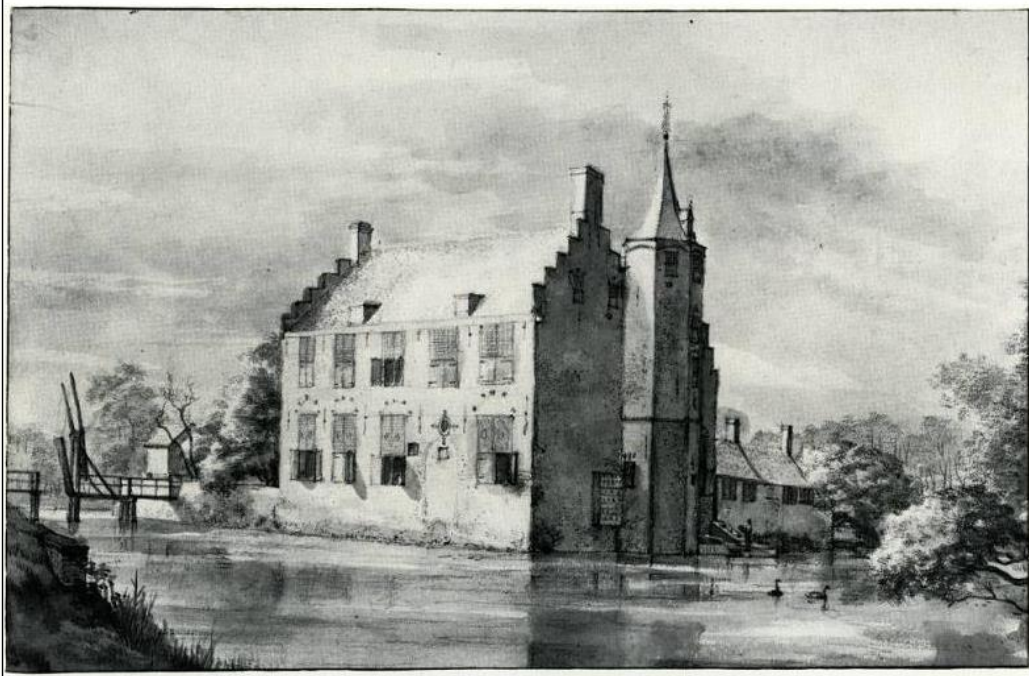
Figure 27: The image of Roelant Roghman, which faces Altena from the north-eastern corner and dates from 1646-1647 (After Kloek 1990, 33; After www.Kastelen Zuid Holland.nl 2003).

Figure 27 displays Altena after its reconstruction of 1612. The image displays the main structure, together with the brick-built tower containing the staircase. The Drawbridge and the building next to it are depicted. On figure 27, large cross-windows are present. On the top of the north side of the roof, a window of the “*kloostervenster*” type appears to be present. Both types of windows are in use during the period 1300-1700, yet the large windows appear during the 17th century (Janse 1971, 38-39).

Furthermore, a round window appears on the main structure. On this location, an outline of a former door is visible, which has been sealed off. Chimneys appear, together with decoration on the brick-built hall in the form of arches. These arches are described as “*Boogvriezen*”, unfortunately these elements could not be dated (Hermans 2013, 60). The first of these arches appears around the 12th century, it disappears somewhere in the 18th century (Haslinghuis and Janse 1997, 91). The shape of the roof follows the crow-stepped gable design, which appears around 1600 (www.Kwaard.net 2004).

Figure 28 displays several elements, which appear on figure 27. The main structure, the brick-built hall, the windows and the arches on top of the tower appear.

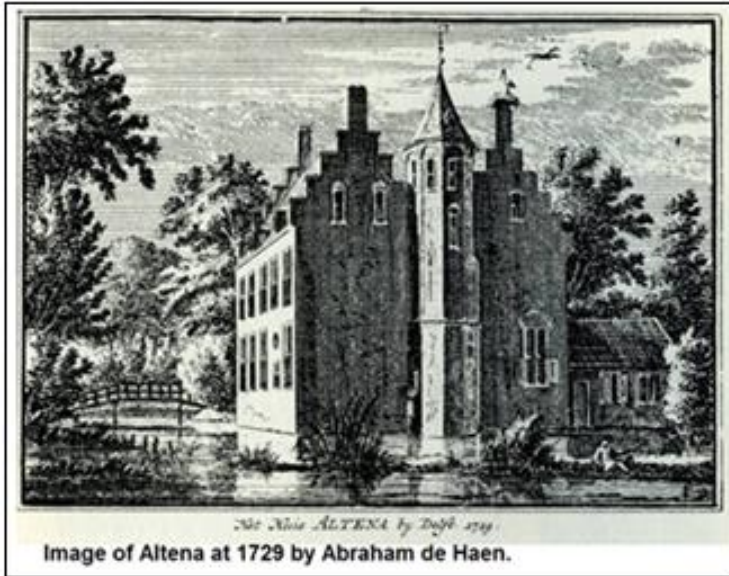
Figure 28: The images of Altena in 1729 by Abraham de Haen, facing the castle from the North side (After www.Kastelen Zuid Holland.nl 2003).

This image displays that the roof on the east side of the structure is wider than the opposing side. The drawbridge seems to have been replaced.

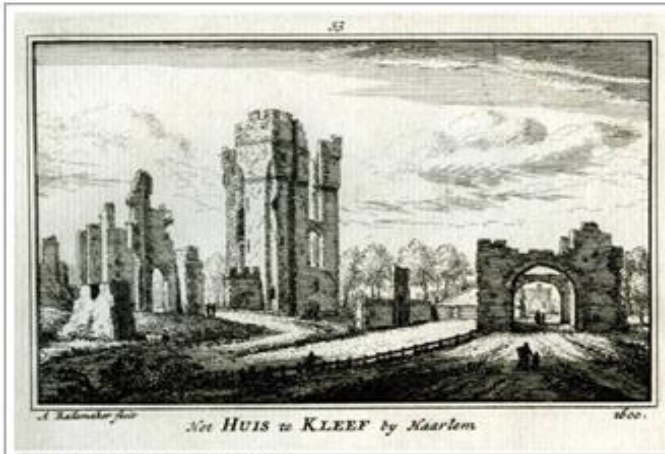
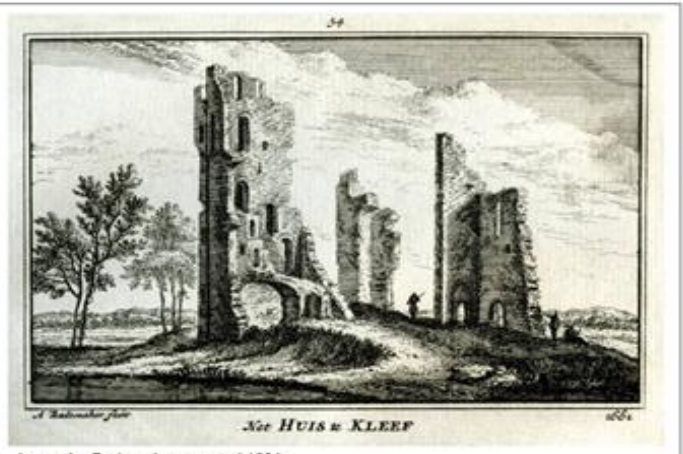
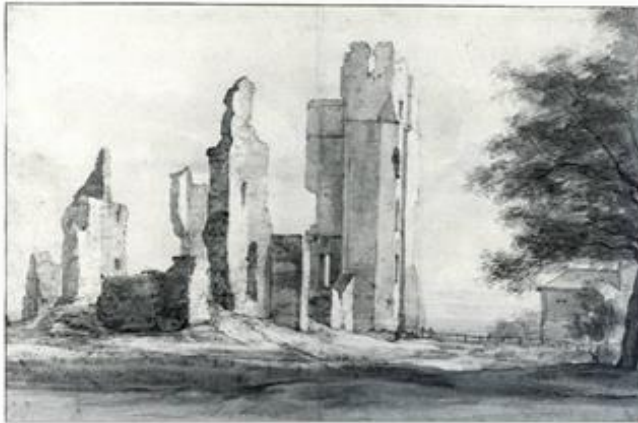
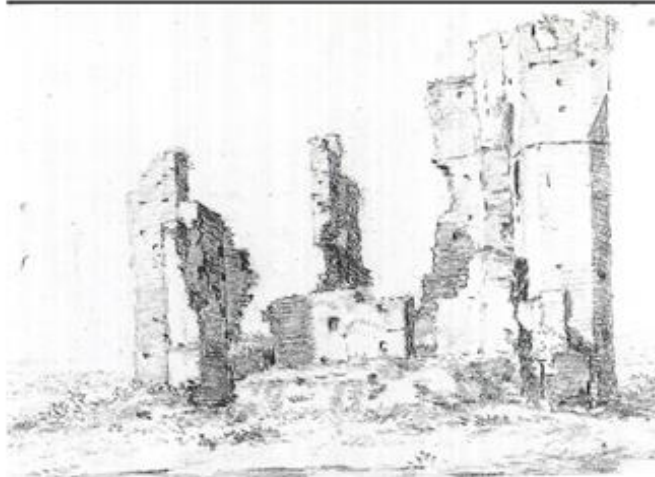
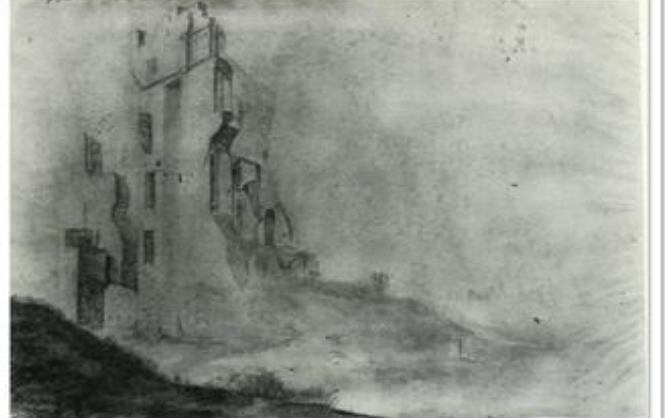
Figure 36: The images of the ruin of Huis ter Kleef (After Kamphuis and Viersen 1995, 41-50: www.Kastelen in Nederland.nl 2019).

The images on figure 36, from top left to bottom right depict (Kamphuis and Viersen 1995, 41-50; www.Kastelen in Nederland.nl 2019):

The six images on figure 36 all display Huis ter Kleef in a state of ruin. The still recognizable brick-built hall does appear to possess four levels, such as figure 35 suggests. These images are of use for the assumption to the height. The remaining brick-built hall appears to have a considerable height if three four were present. It can be assumed that the tower possessed a length of 20 meters high, (which includes the roof structure). The remaining walls of the other structures suggest that these buildings could have reached a height of around 15 meters.
